# PINNACLE RIDGE CONCEPT PLAN

A proposed country residential community on the  
northerly portion of NE 1/4 S19 T24 R2 W5M located in the  
Springbank area within the Municipal District of Rocky View N<sup>O</sup>44.

Prepared by

December 21, 1995

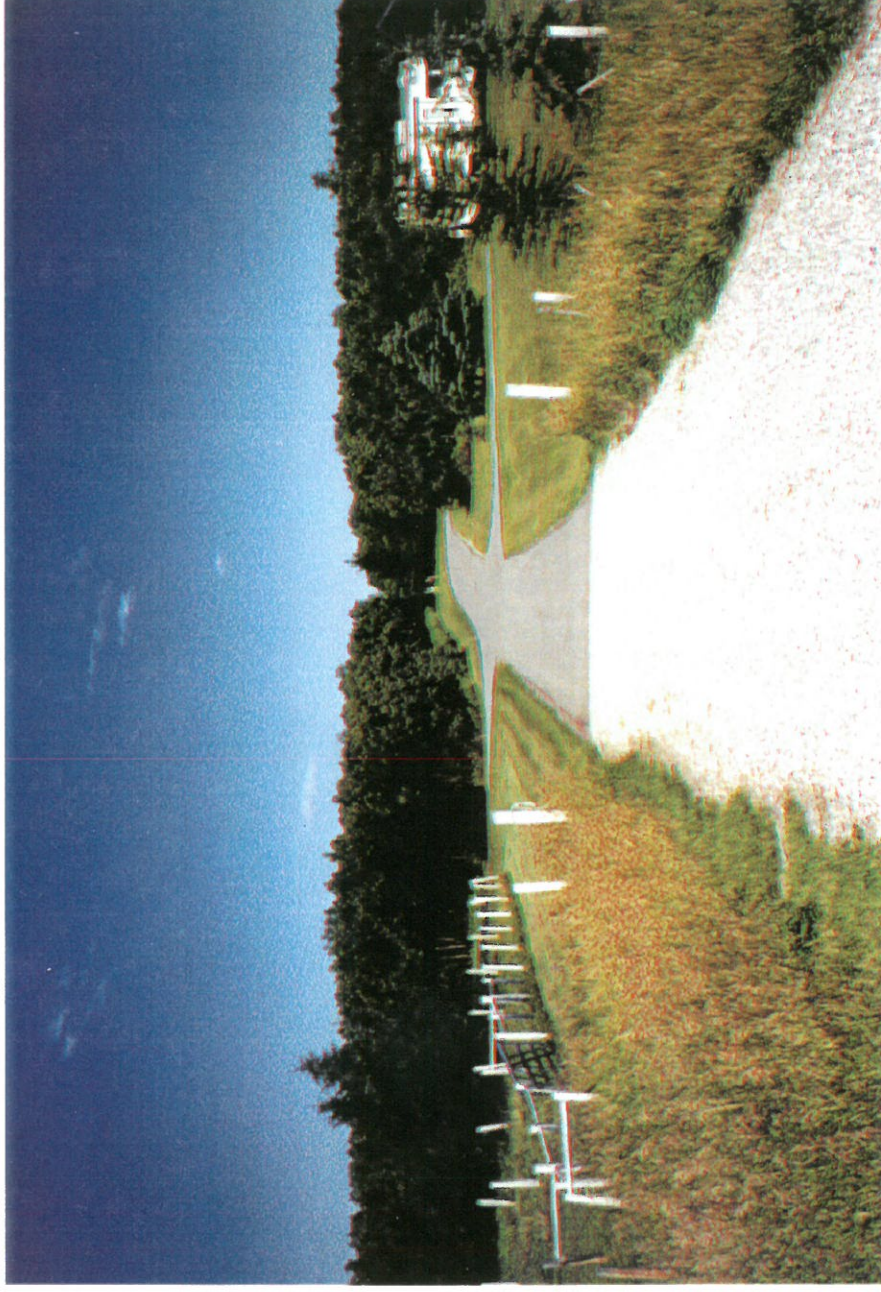
FIGURE 7(A): TREE DISPLACEMENT COMPARISON

Looking north between proposed lots #24 & 49

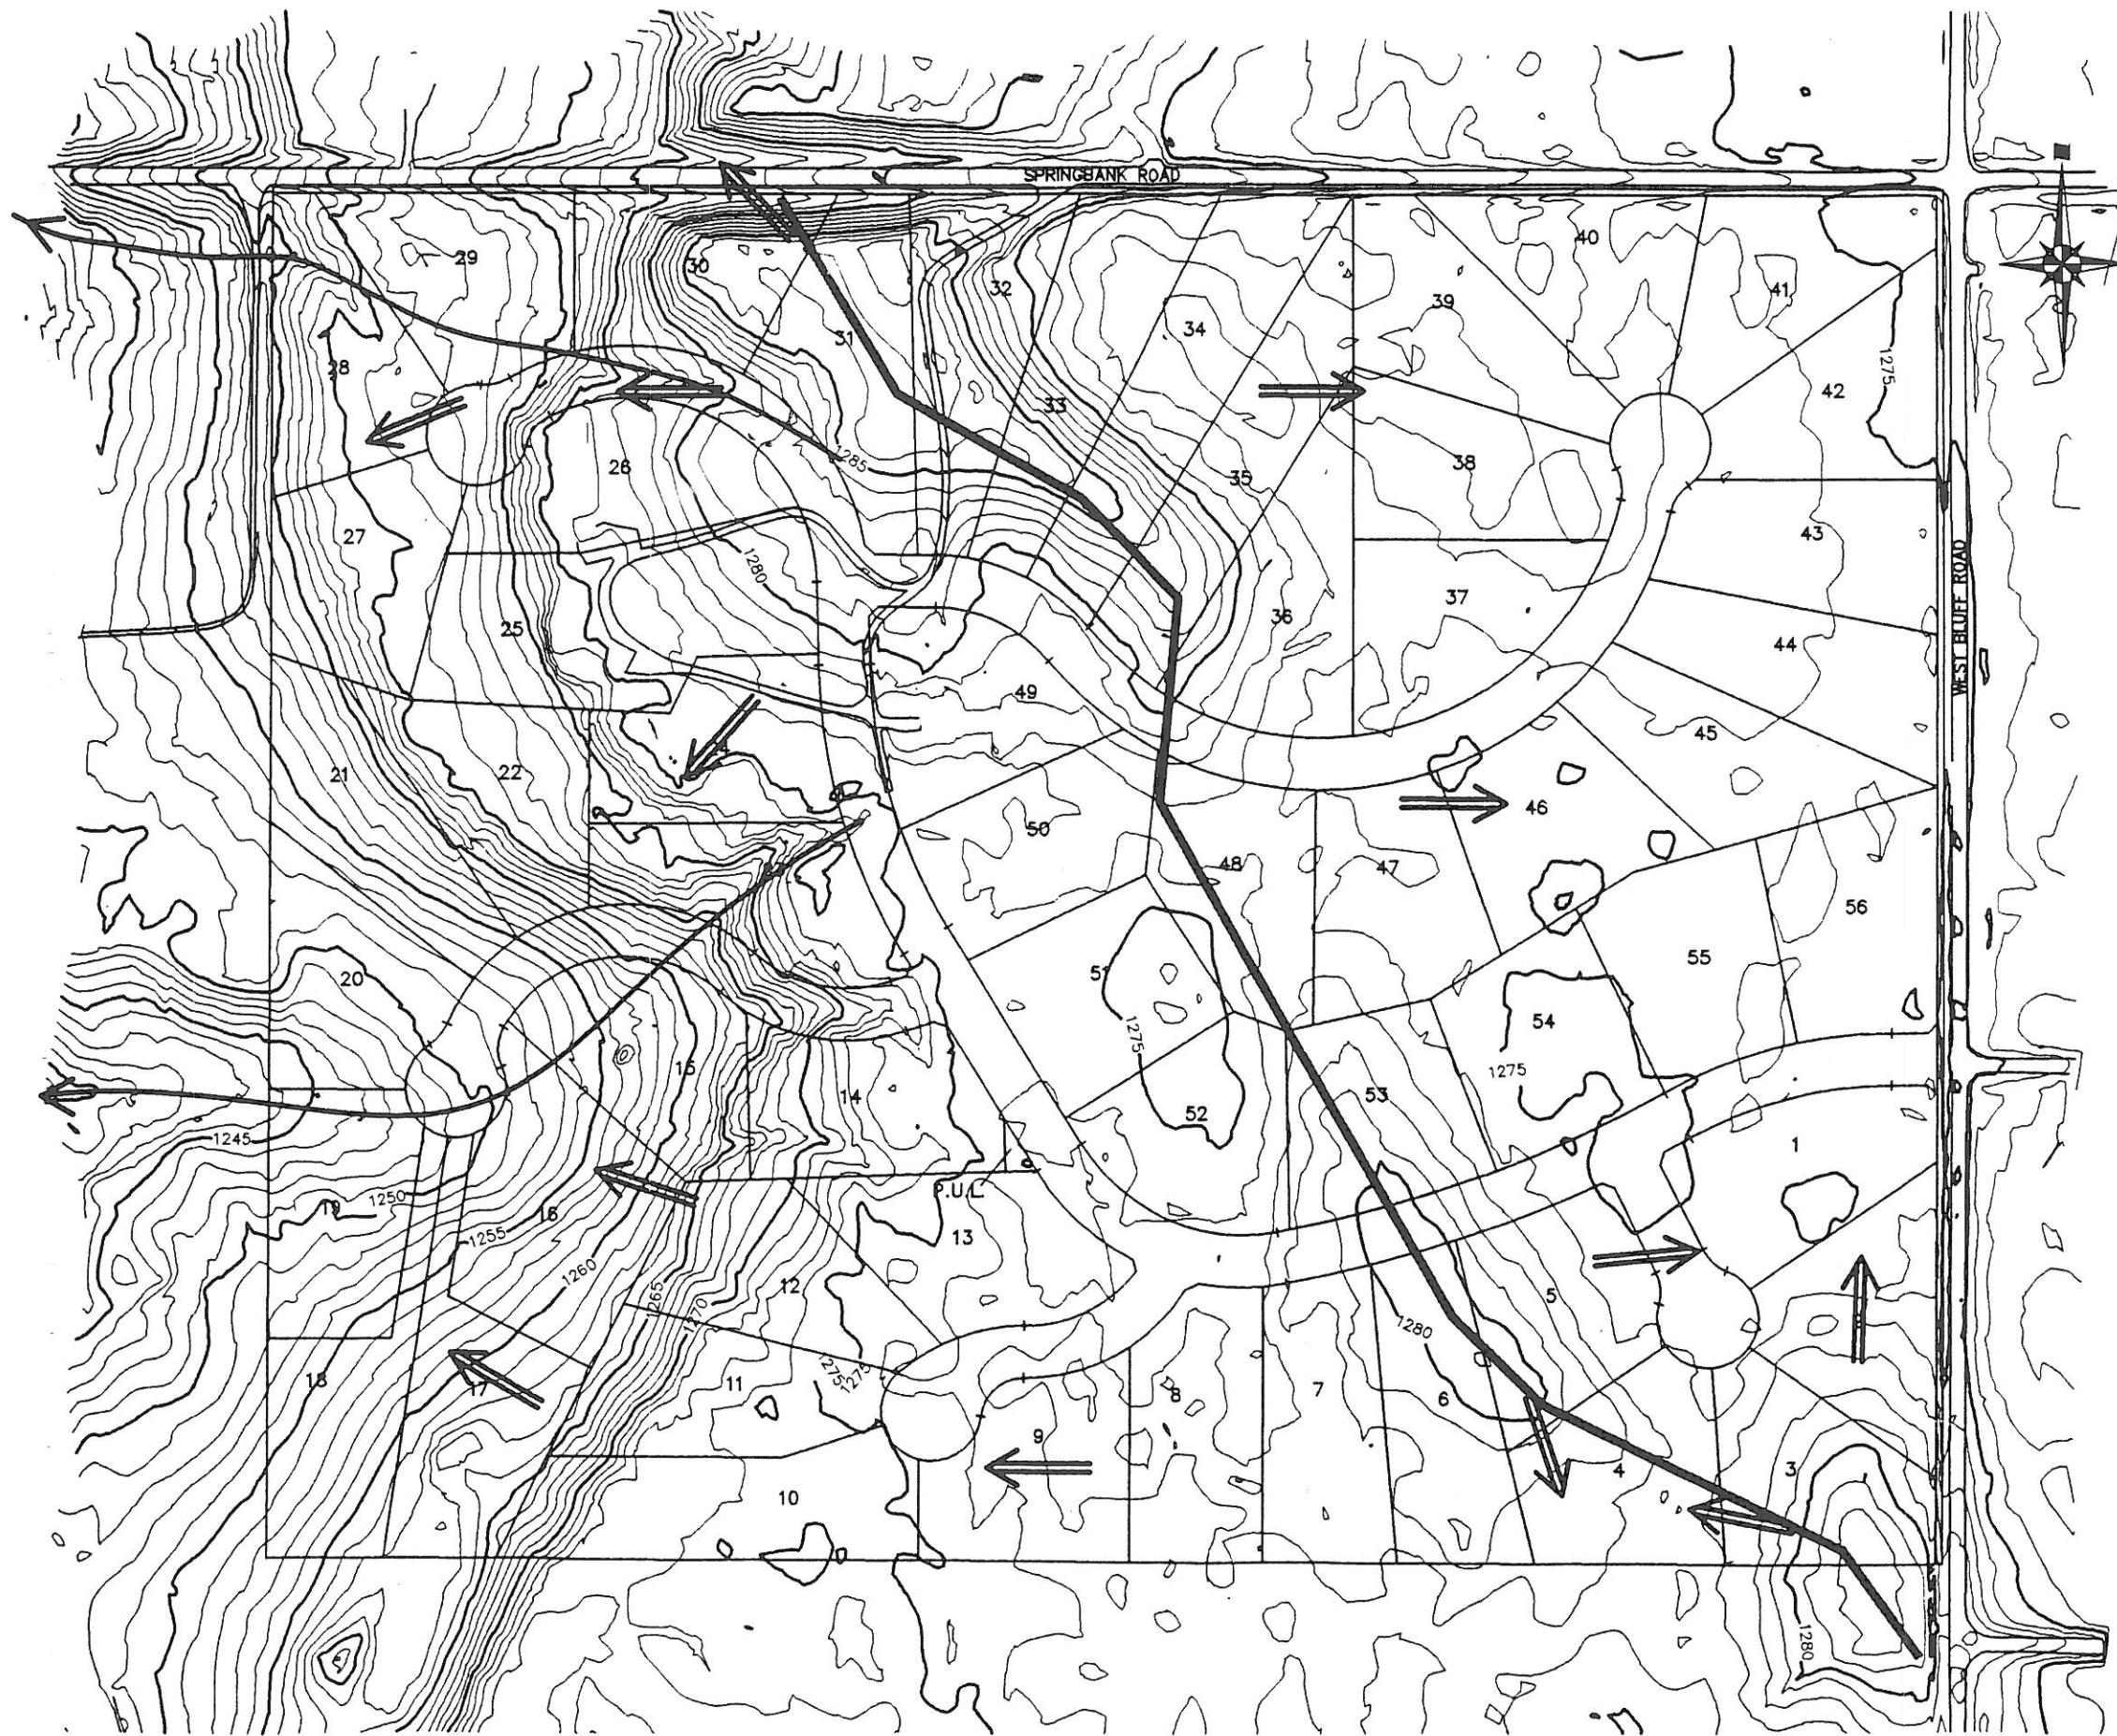
DESIGN BY: H.M.  
DRAWN BY: WOC  
CHECKED BY: H.M.  
DATE: 96 - 08  
SCALE: NTS  
JOB NUMBER: 96 - 033  
DRAWING NUMBER: D

The predevelopment drainage conditions for the subject area are shown on Drawing D. The existing topography shows a rolling terrain, steep in certain areas, with a ridge that divides the subdivision into two drainage areas. The west drainage area which makes up slightly greater than one half of the development area flows into the natural drainage path provided by the existing coulee. The rest of the area drains to the east as a sheet flow, uniformly dispersing the flow to the road ditch.

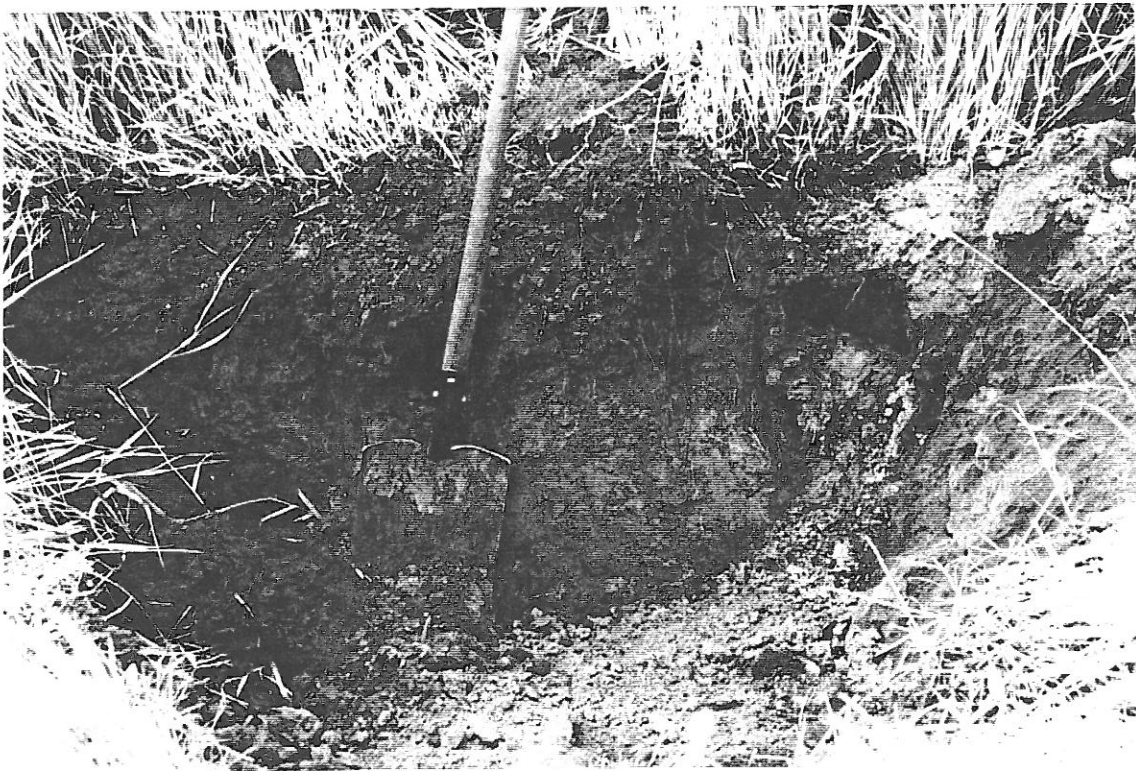
Plate 3. Backhoe test showing typical soil profile.

Soils in the low areas tested by backhoe were deeper. Glacial clay was encountered at depths of 60 cm, 80 cm, and 110 cm. However, none of the backhoe tests exhibited any buried soil horizons. Nor were any historical resources found in the backhoe tests. Plate 3, page 9, shows the profile of a typical backhoe test.

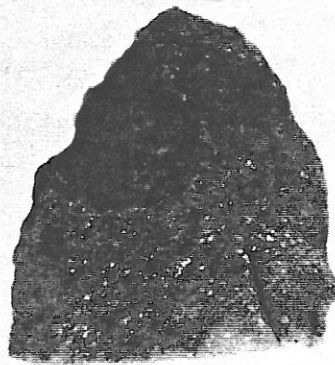
Plate 6. Biface tip (EgPn-425-1).

The assemblage contains two formed artifacts, both of which were recovered in one area. A quartzite biface tip was recovered from a shovel test located adjacent to Test Unit E35S0. The biface is shown in Plate 6, page 16. It is 42 mm long, 36 mm wide, 10 mm thick and weighs 16.3 g. It is made of a fairly coarse granular quartzite and does not exhibit any use wear.

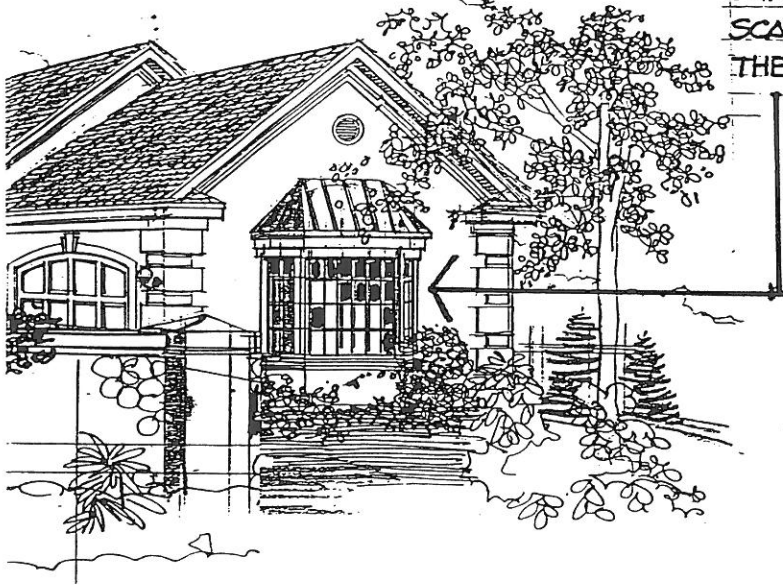
GARAGE WALLS TO FACE  
SIDE WALL OF GARAGE TO FACE  
ON TO ENTRY DRIVEWAY AND CONTAIN A DECORATIVE  
WINDOW TREATMENT  
SCALED TO ENHANCE  
THE WALL

- Garage detailing should include the same detailing emphasis as the rest of the house exterior.

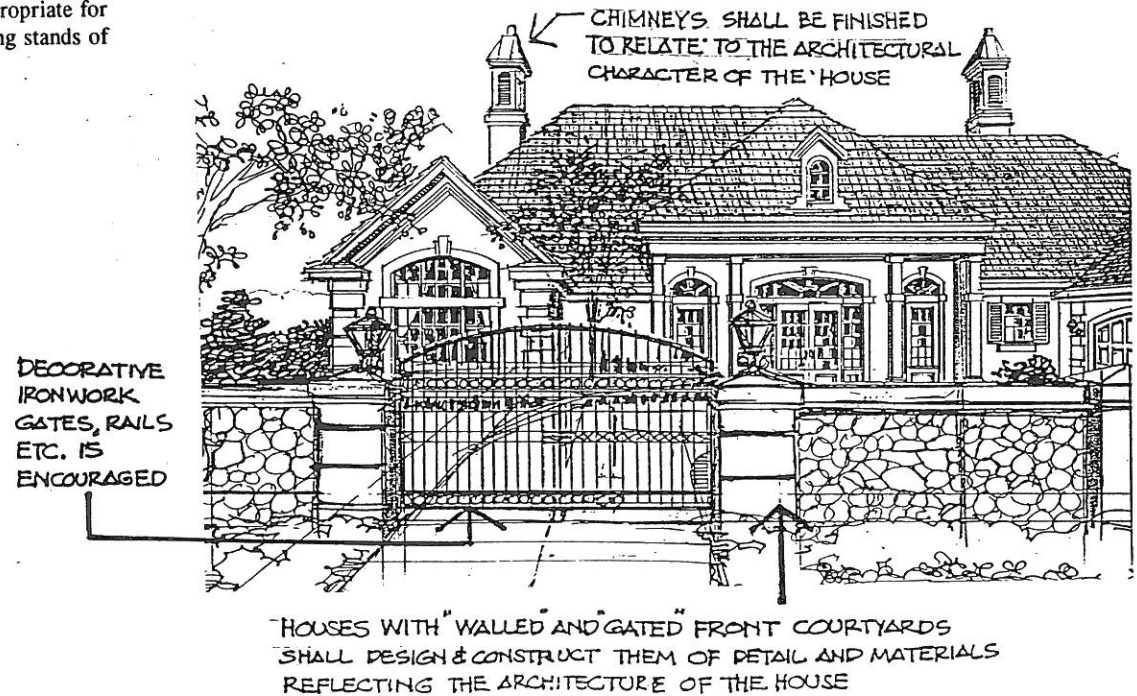
- Attention should be paid to add chimney detail that is consistent with cornice and eave detail.
- Privately initiated fencing and gating is to be within a 40 foot radius of the house exterior (subject to being appropriate for the lot and not detrimentally impacting the existing stands of trees).
