**AQUATIC ENVIRONMENT ASSESSMENT
BRAGG CREEK FLOOD MITIGATION PROJECT
BRAGG CREEK, ALBERTA**

Amec Foster Wheeler Environment & Infrastructure

Rocky View County

July 2017

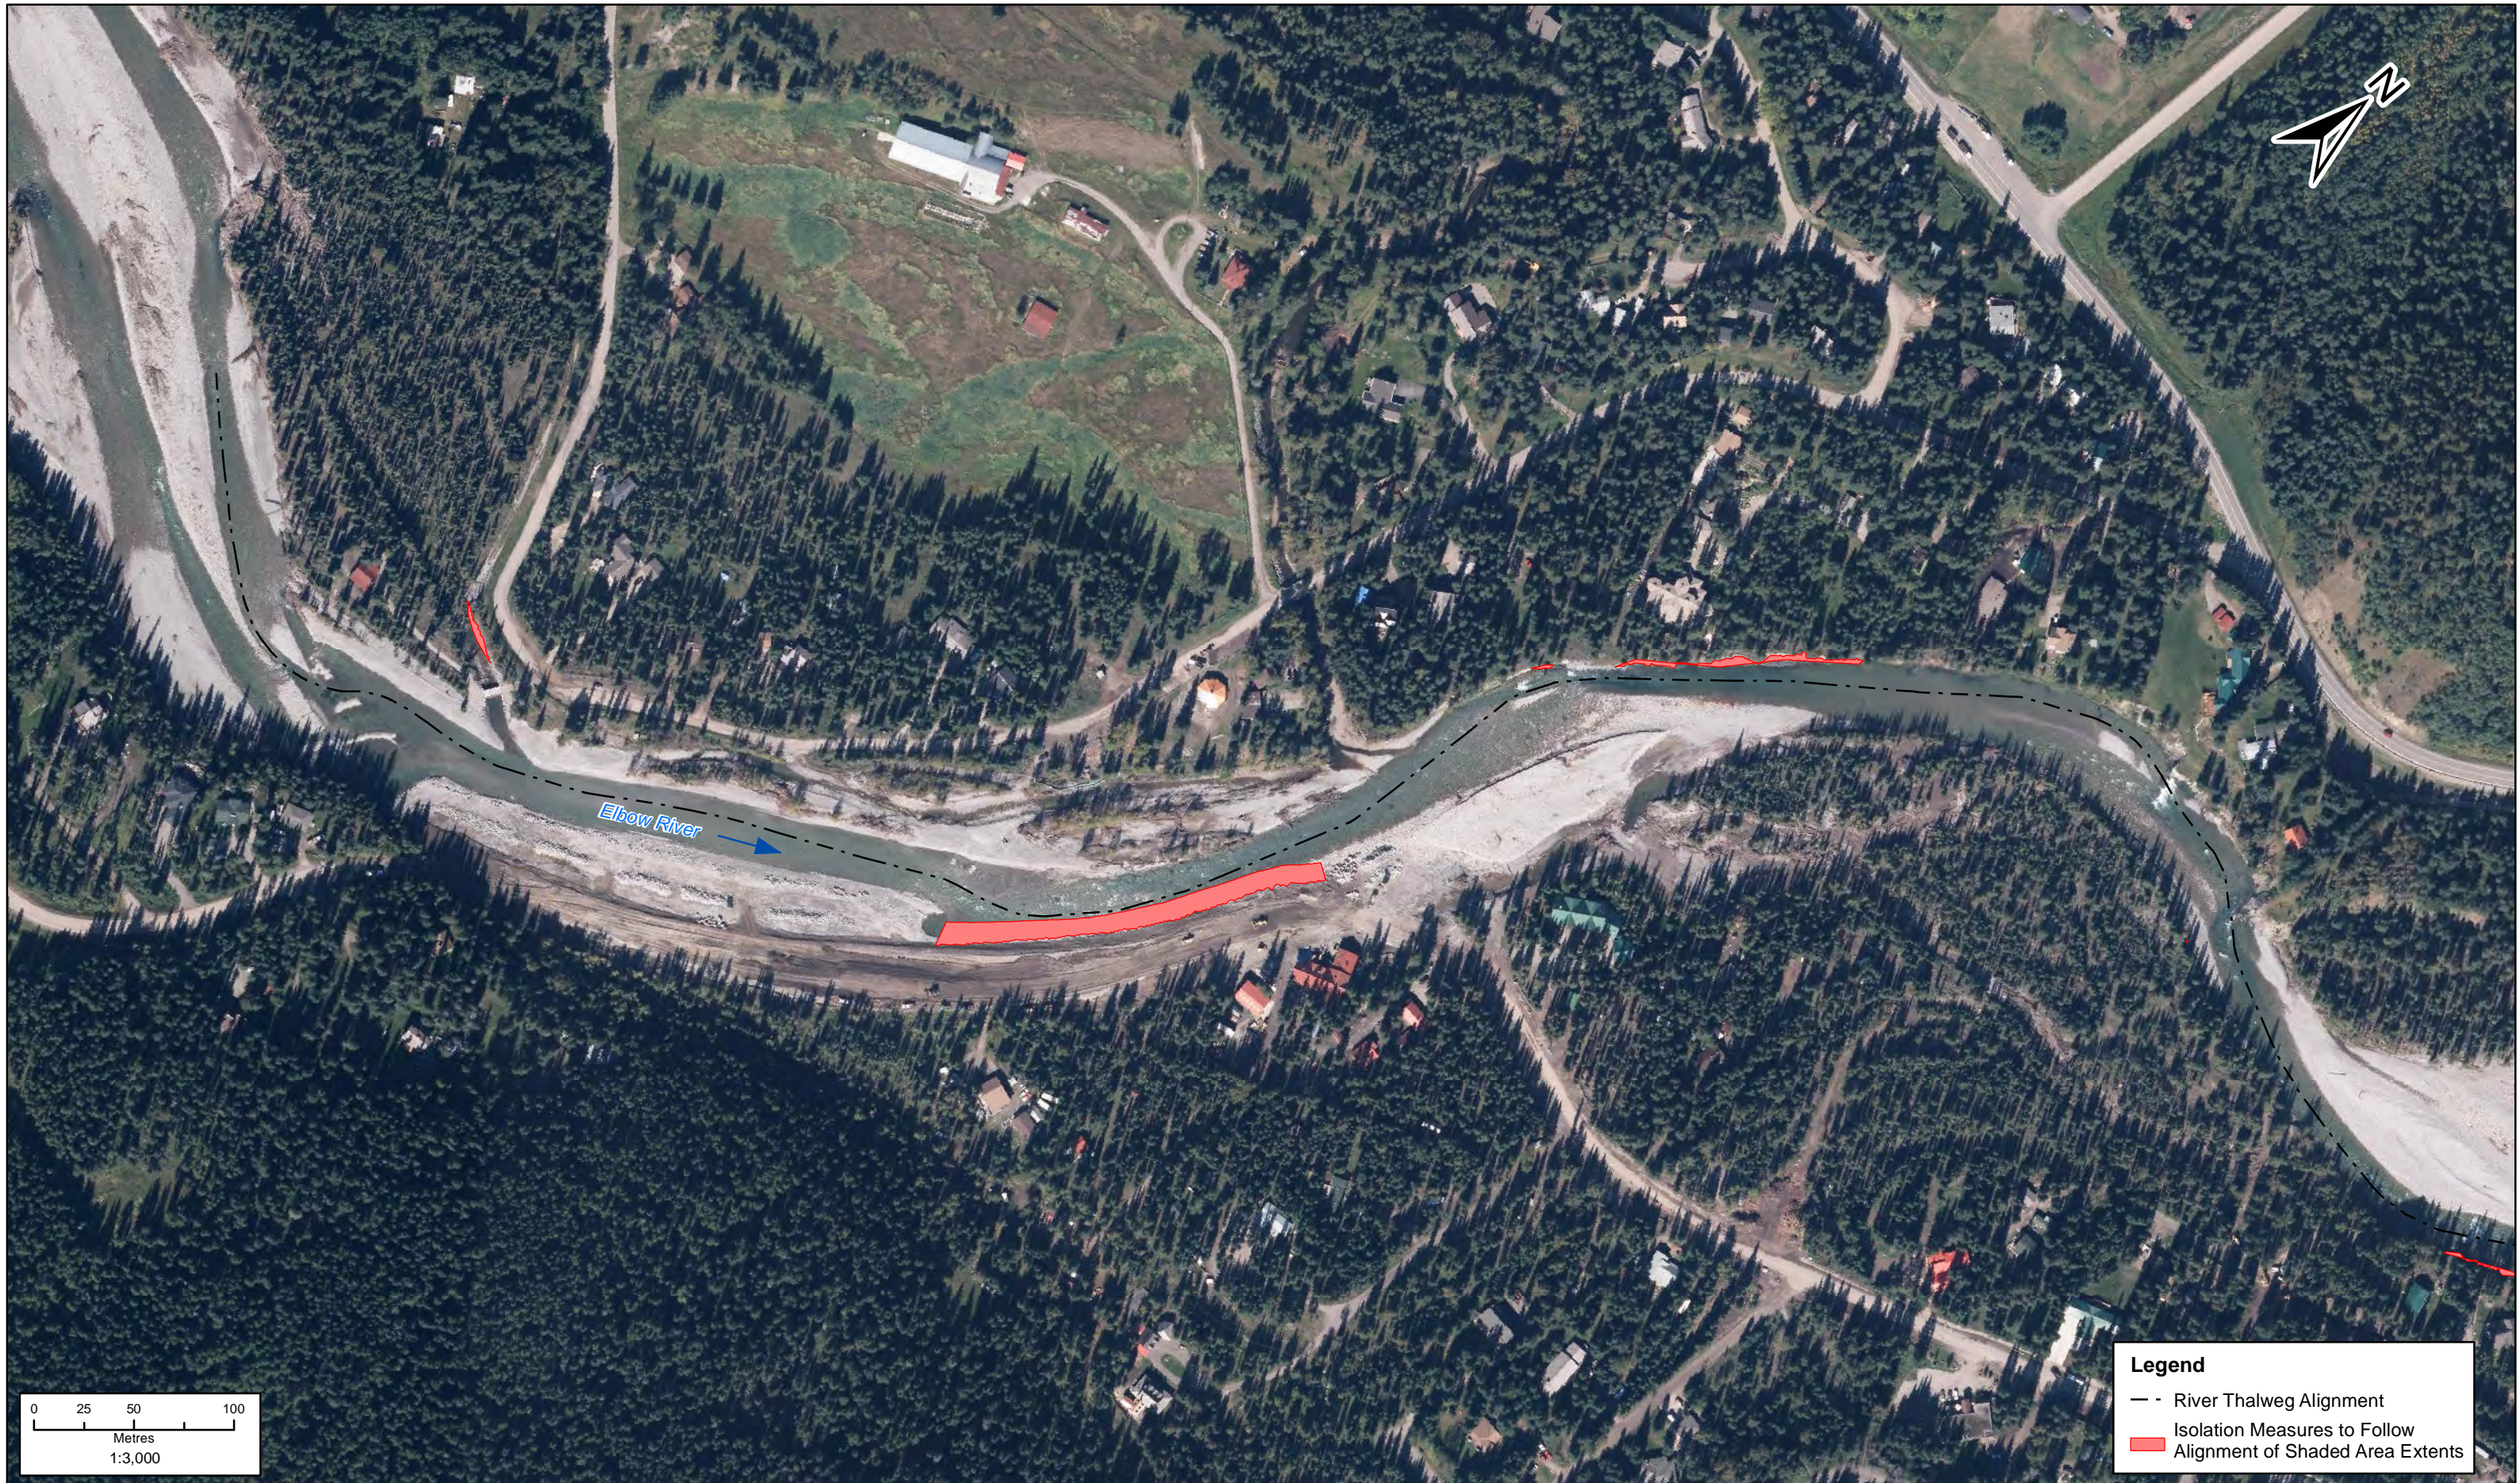
Figure 3 Approximate Isolation Alignment (Southern Portion of Structure)

Areas that have been identified as potentially requiring isolation are highlighted on Figure 3 and Figure 4.

All components of the work that require instream activity will be isolated from the main channel to ensure that fish are not directly affected and instream activities do not release sediment to downstream areas of the river.

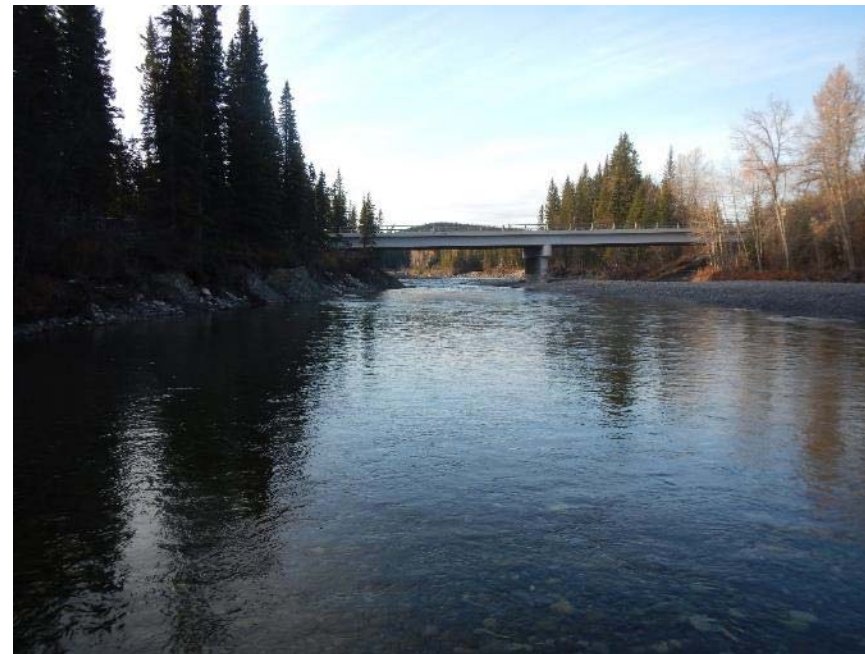
Photo 1: Facing upstream from transect 1 showing slow velocity run habitat and the Balsam Ave Bridge. 4 October 2016

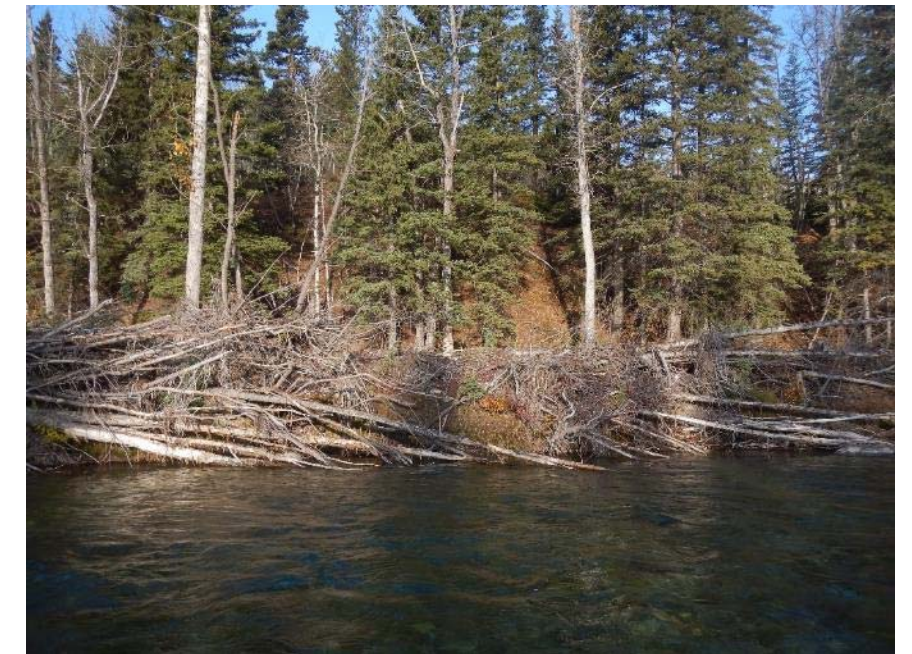
Photo 2: Rafter large woody debris on the left bank of transect 2. 4 October 2016

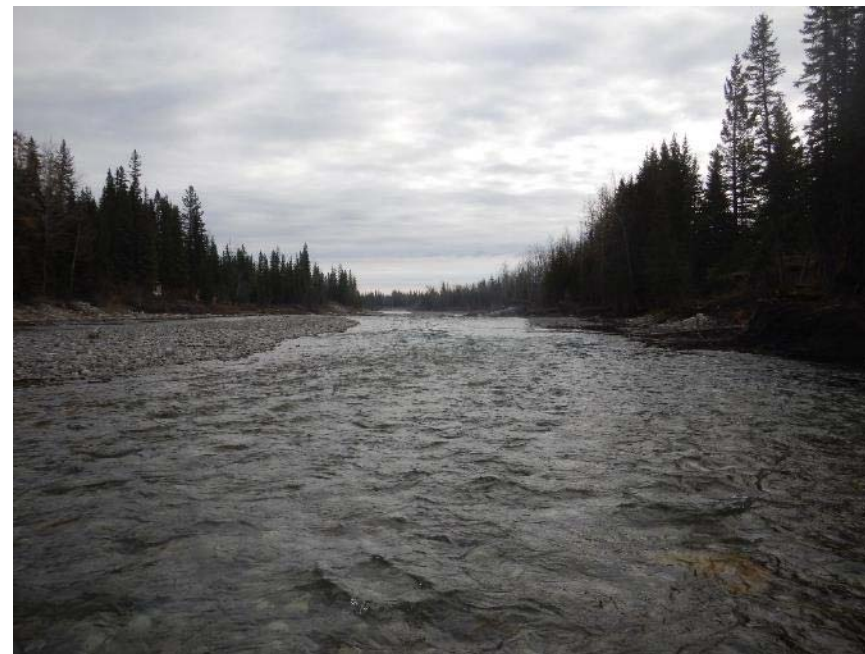
Photo 3: Typical riffle habitat downstream of transect 3. 4 October 2016

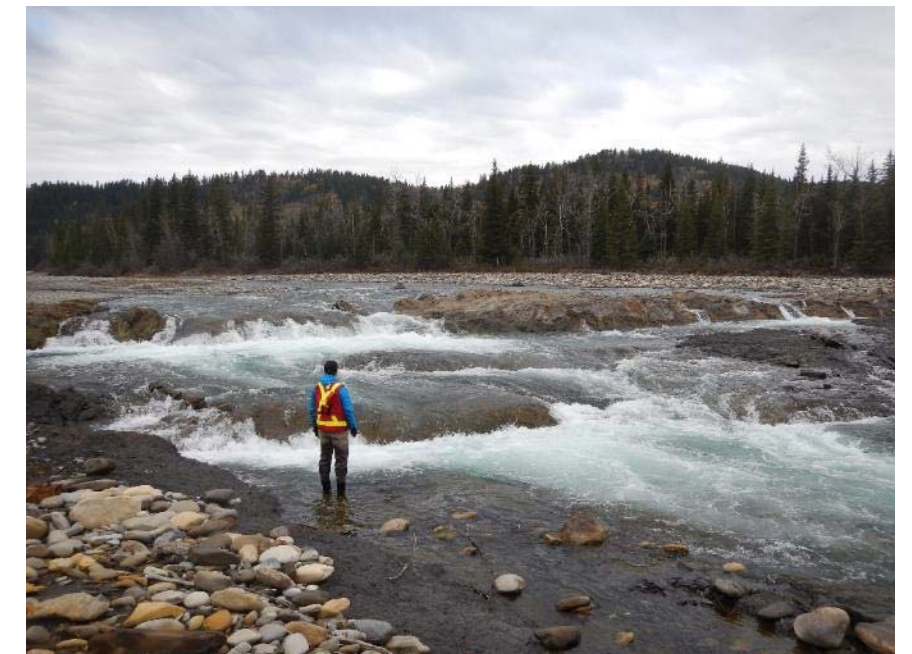
Photo 4: Falls between transects 4 and 5. 4 October 2016

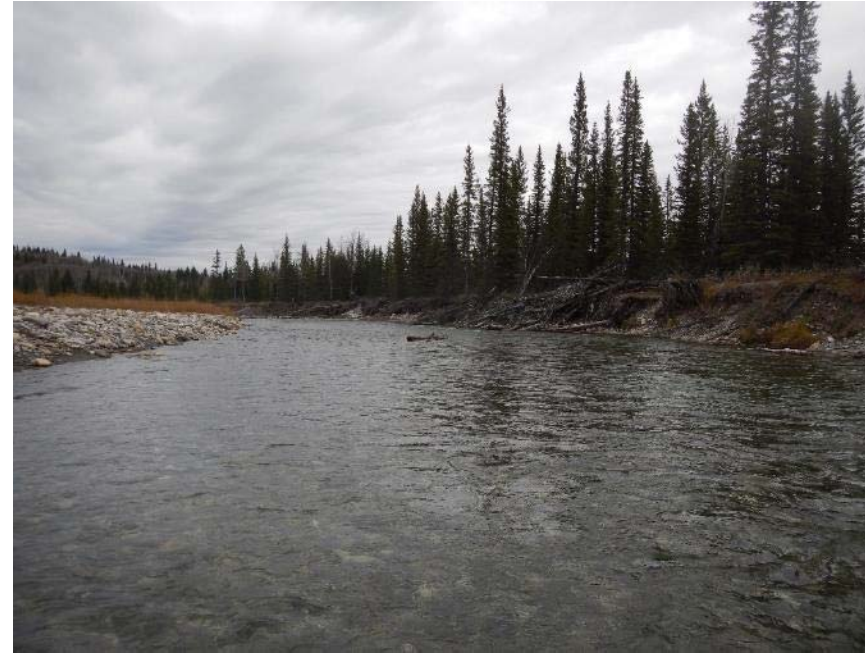
Photo 5: Facing downstream from transect 6 showing typical run habitat and left cut bank with large woody debris. 4 October 2016

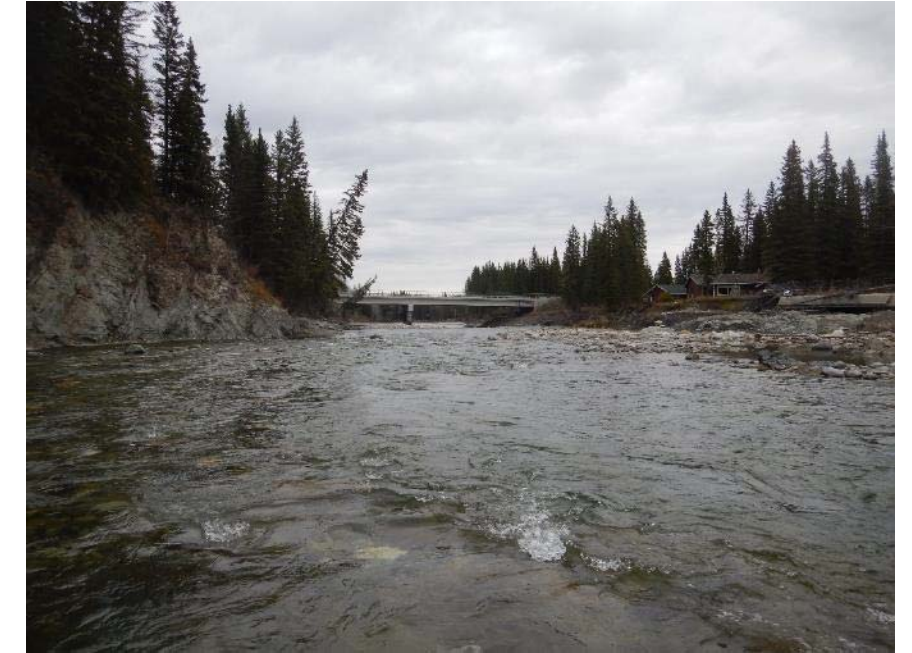
Photo 6: Looking downstream from transect 7 showing large bedrock outcrop along the right bank and the Balsam Ave Bridge in the distance. 5 October 2016

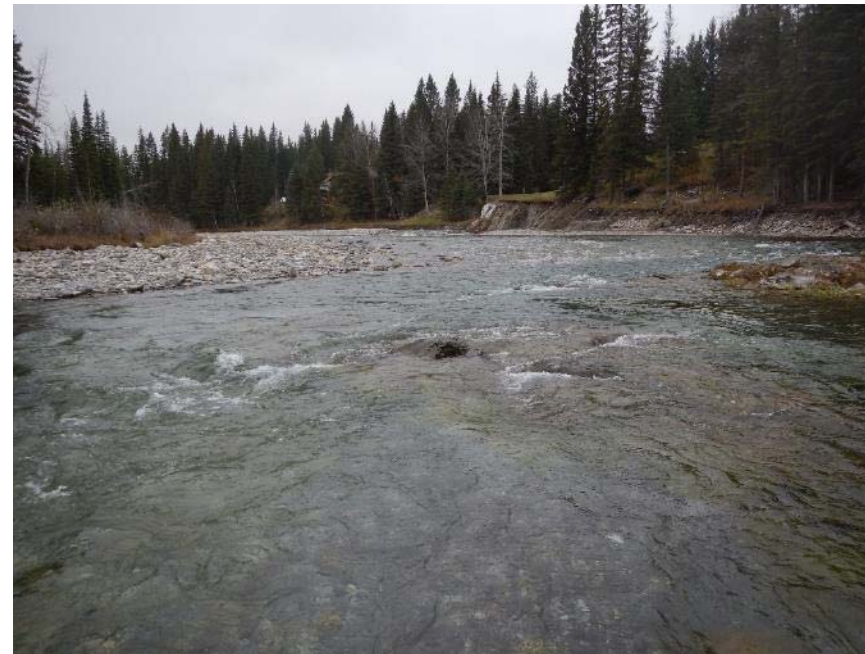
Photo 7: Facing upstream from transect 9 showing riffle habitat over bedrock substrate. 5 October 2016

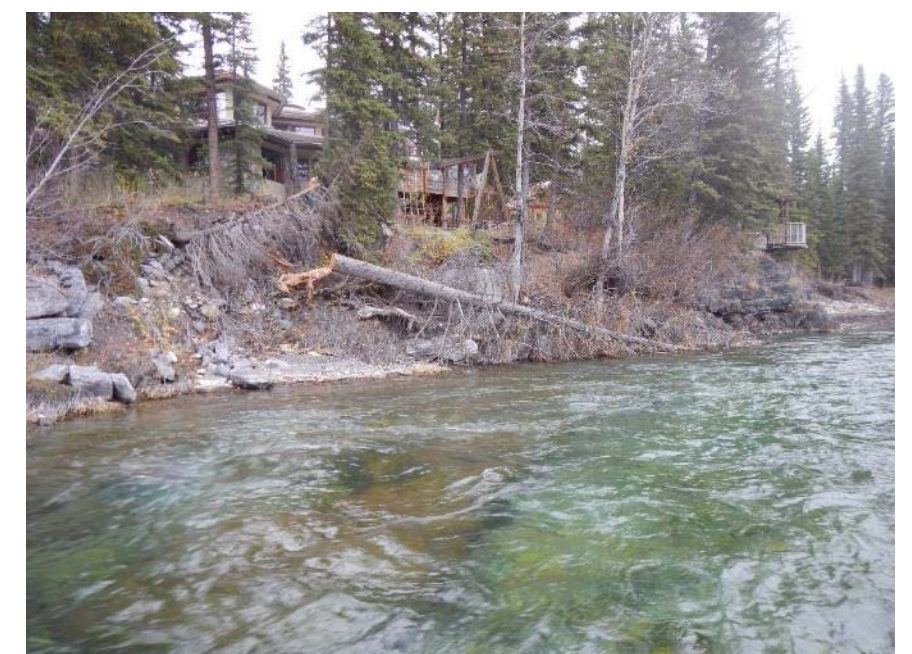
Photo 8: Left bank at transect 10 showing large woody debris and adjacent residential housing. 5 October 2016.

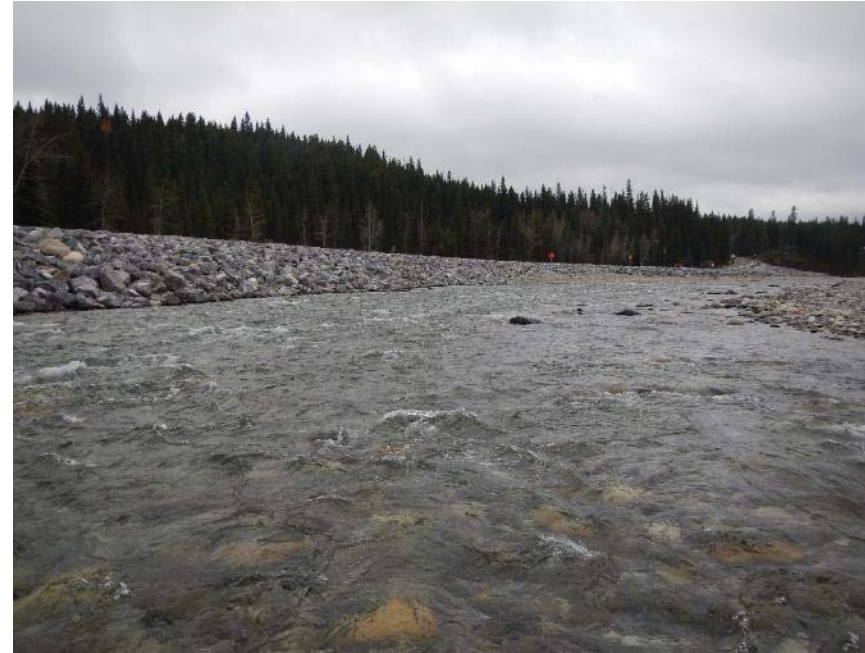
Photo 9: Looking upstream from transect 11 showing existing riprap bank protection 5 October 2016

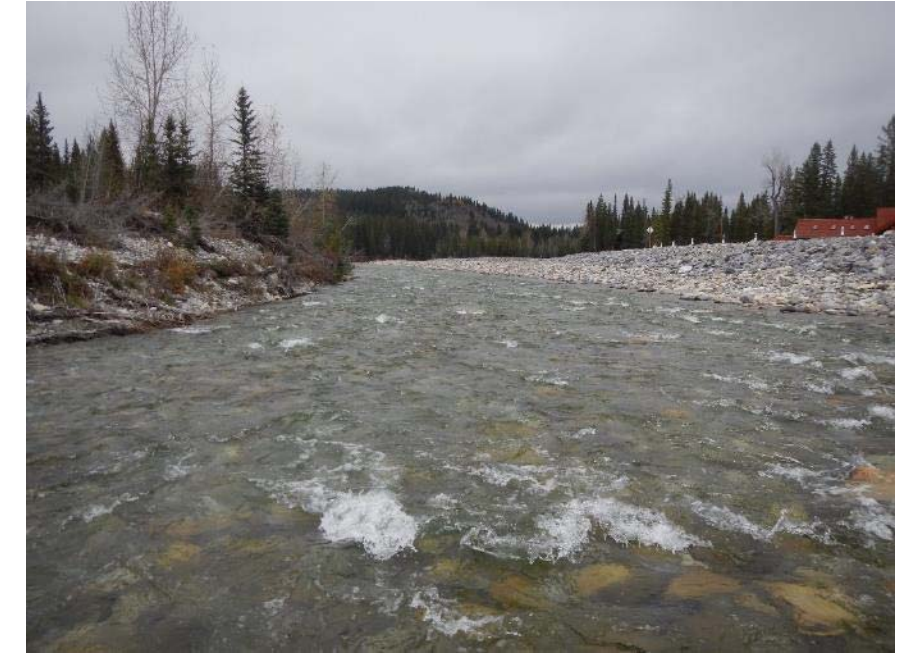
Photo 10: Typical riffle habitat downstream of transect 11. 5 October 2016

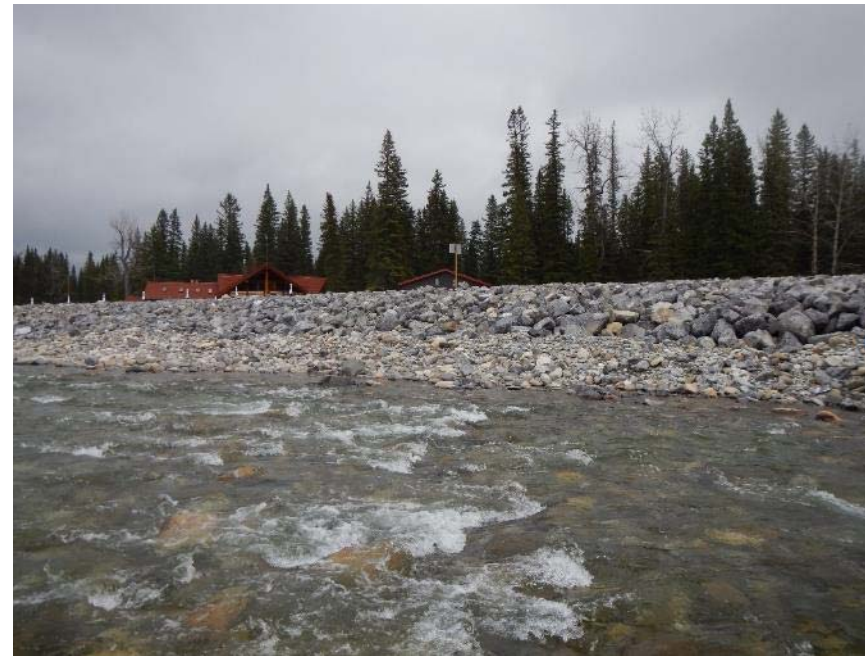
Photo 11: Existing riprap bank protection along the right bank extending past transects 11 and 12. 5 October 2016

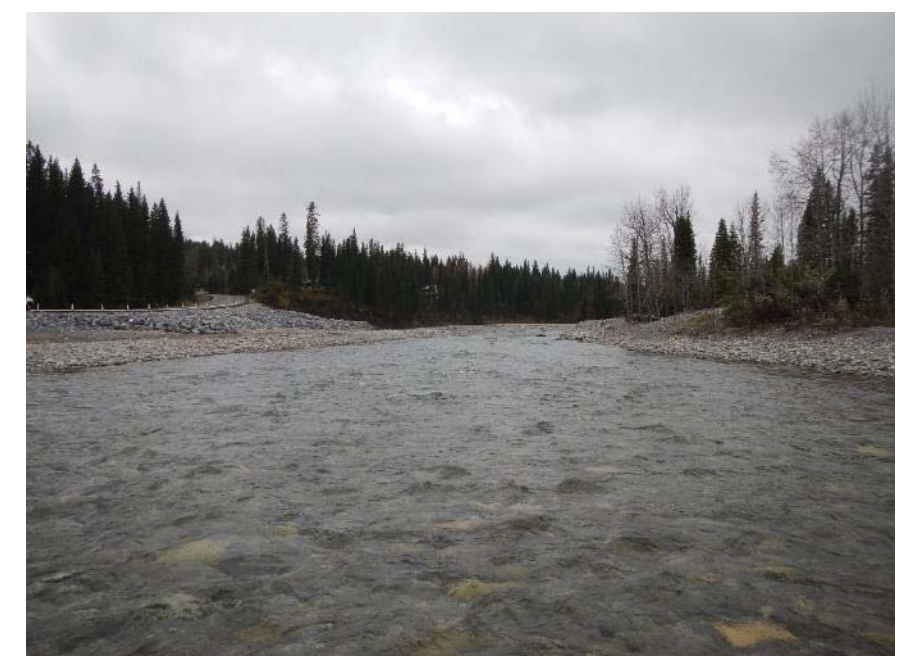
Photo 12: Looking upstream from transect 12 showing run habitat transitioning into riffle habitat. 5 October 2016

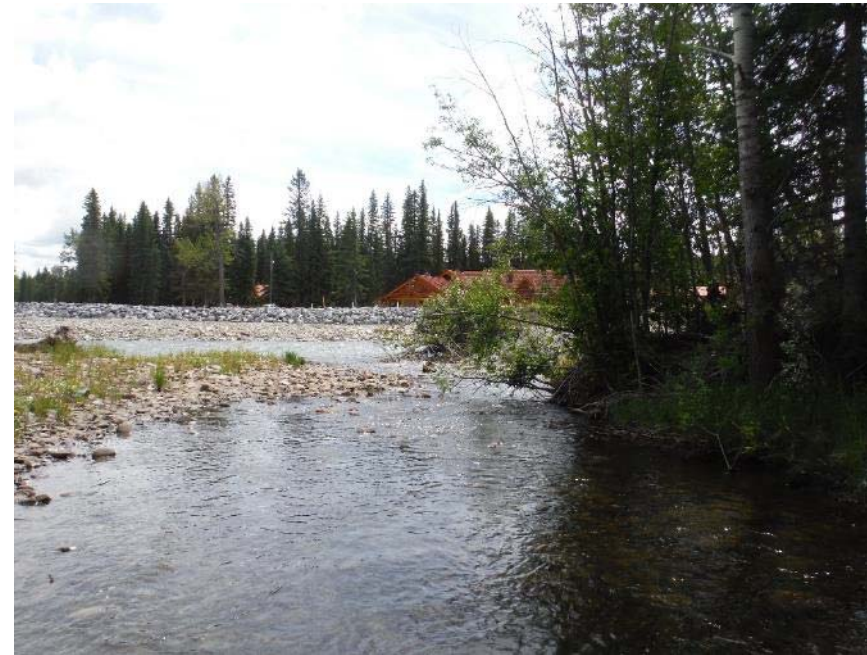
Photo 2 – Looking downstream from transect 2 showing the confluence of Bragg Creek and the Elbow River. 22 June 2017

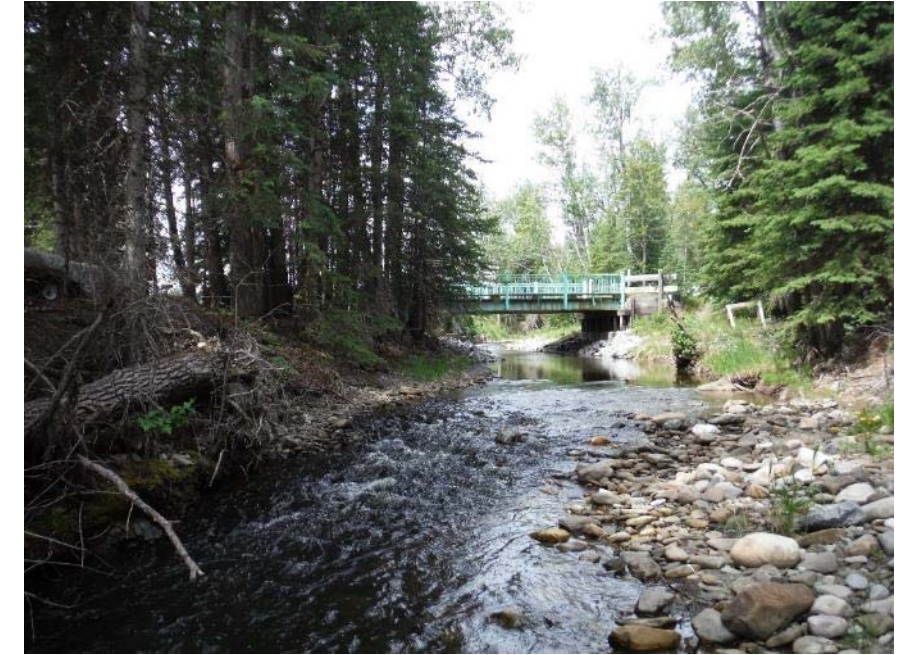
Photo 1 – Looking upstream at high velocity riffle habitat and the Bracken Road Bridge. 22 June 2017

Habitat within Bragg Creek was characterized by moderate to high water velocities and shallow depths (<0.7 m). Habitat was primarily run alternated by short riffle sections (Appendix B). Pool habitat was rare and only observed immediately downstream of the Bracken Road Bridge.

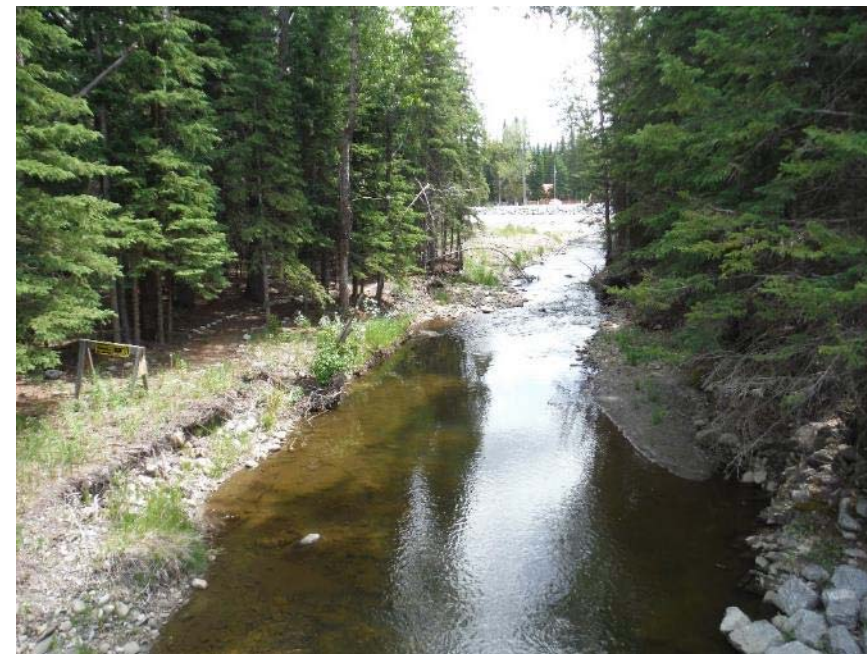
Photo 3 – Looking downstream from the Bracken Road Bridge. 22 June 2017

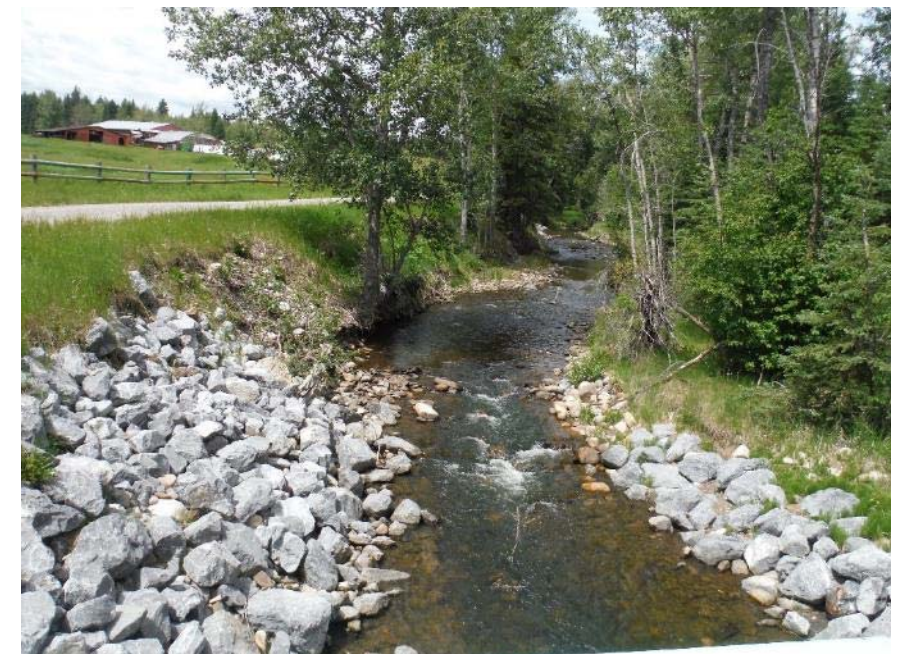
Photo 4 – Looking upstream from the Bracken Road Bridge. 22 June 2017
